### Testing of Sealtight and Sodium Silicate Solution Treatments on Mortar

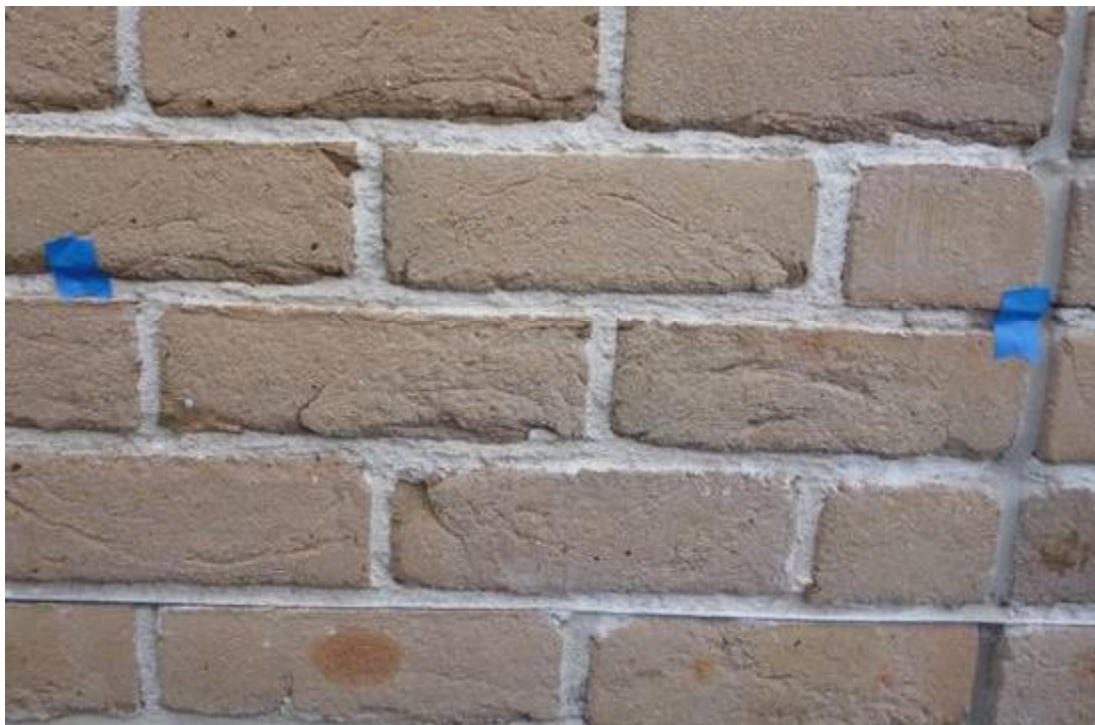
35. A scan around the house, using point tests, identified 2 areas of non-compliant mortar for the trial. The mortar joints chosen were adjacent to the articulation joint and 2 bricks south for the lower joint, on the rear panel of brickwork on the south-eastern elevation. The mortar joint selected for the sodium silicate trial was the 3<sup>rd</sup> mortar bed above the DPC. The mortar joint selected for the Sealtight trial was the 1<sup>st</sup> mortar bed below the DPC.

Figure 2. Joint chosen for sodium silicate trial (marked either end in blue)

36. The selected joints were tested for Scratch Index and then Sealtight and sodium silicate were brushed on the respective joints using an 18 mm detail brush until the joints had a wet appearance. Sealtight is reported to work with one application; however, on the 30<sup>th</sup> August, Mr Vincent applied a second application to one end of the original trial area in case it was necessary to have 2 applications.
37. On 6<sup>th</sup> September the treated areas or the joints were tested for Scratch Index.
38. The results of all Scratch Index tests are shown below:

Sodium silicate trial area one week after 2<sup>nd</sup> application

Sample Location	Individual Scratch Tool Measurement (inches)	Individual Scratch Tool Measurement Converted to mm	Individual Scratch Tool Measurement Rounded mm	Scratch Index Result (mm)	Pass/Fail
South-East elev.	0.002	0.0508	0.05	0.045	Pass M3 & M4
rear panel	0.006	0.1524	0.15		
adj. A. Joint	0.001	0.0254	0.025		
3 courses above	0.000	0	0		
DPC	0.000	0	0

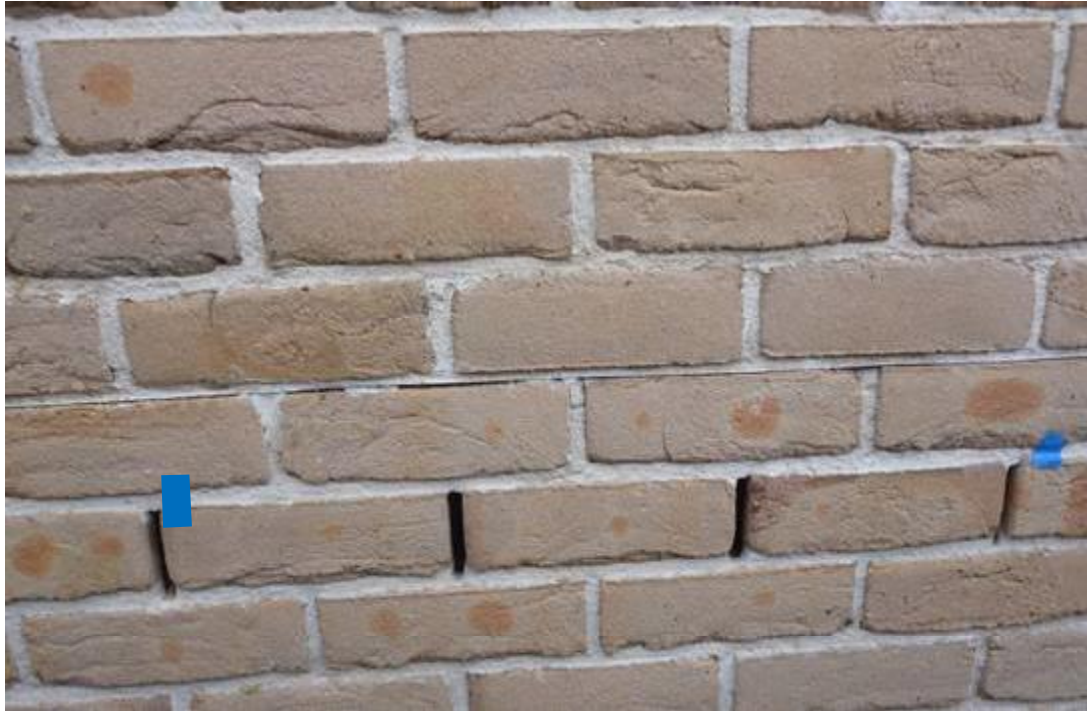
Figure 3. Joint chosen for Sealtight trial (marked either end in blue)

## Sealtight trial area after 1 application

Sample Location	Individual Scratch Tool Measurement (inches)	Individual Scratch Tool Measurement Converted to mm	Individual Scratch Tool Measurement Rounded mm	Scratch Index Result (mm)	Pass/Fail
South-East elev.	0.004	0.1016	0.1	0.05	Pass M3 & M4
rear panel	0.001	0.0254	0.025		
adj. A. Joint	0.001	0.0254	0.025		
1 course below	0.001	0.0254	0.025		
DPC	0.003	0.0762	0.075
